# John Smith Creek Culvert Removal

## Mendocino County, California

*Mendocino County, California*

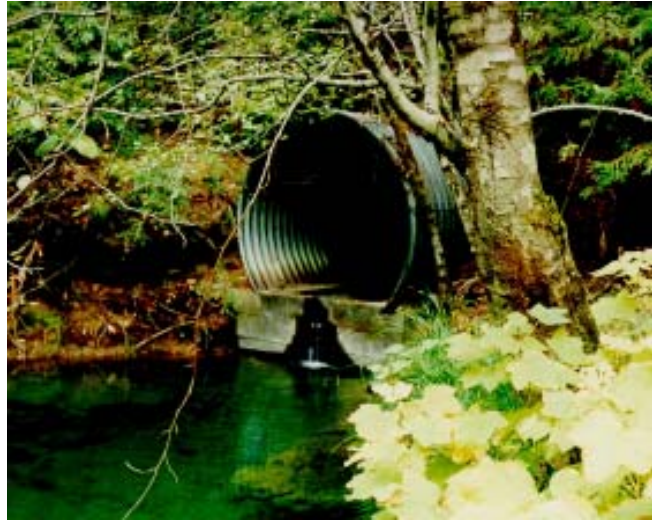
Culvert at low flow

John Smith Creek contains some of the best salmonid habitat in the Navarro River Basin. Unfortunately, a culvert and road crossing at the confluence of John Smith Creek and the Navarro River was blocking fish access to John Smith Creek. The culvert was failing and there was an immediate risk of a giant blowout of the whole crossing if it was not repaired, which would introduce hundreds of yards of fine sediment into an already sensitive system. The road above the culvert was a main thoroughfare for Mendocino Redwood Company and could not be abandoned. Mendocino Redwood Company wanted to fix the culvert for maintenance and fish passage reasons, but did not have enough money to implement a solution for both problems.

In 2002, the NOAA Restoration Center partnered with Mendocino Redwood Company, Trout Unlimited, the California Department of Fish and Game, and the California Conservation Corps to fix the fish passage problem. The rusty culvert and hundreds of yards of road fill and the roadway were removed. The channel was reshaped, and an 89-foot clear span bridge was installed at the project site. The clear span bridge allowed natural channel movement and fluvial processes to resume, and opened access to approximately 1.5 miles of high quality spawning and rearing habitat for coho salmon and steelhead.

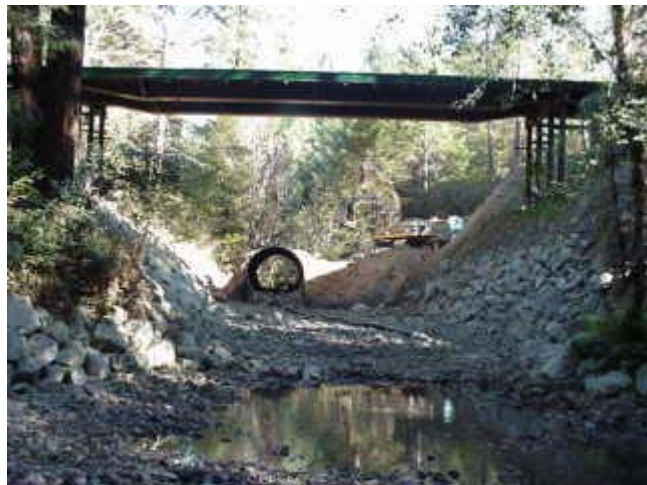
Culvert and bridge during removal and construction, respectively
